# PROJECT DESCRIPTION

## IN-SITU CHEMICAL OXIDATION

### Transfer Pipe Release at Bulk Storage Terminal Dallas/Fort Worth Area, Texas

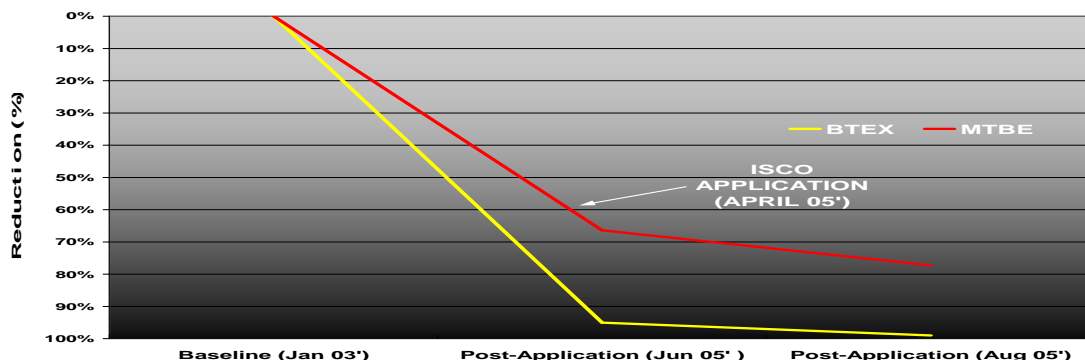
MECX successfully eliminated NAPL and significantly reduced total BTEX by 95% within 1 month after the May 2005 application and to below detection levels after 3 months, as depicted below. Also, MTBE concentrations were reduced to by 66% 1 month after and 77% 3 months after the application.
